DEPARTMENT OF TRANSPORTATION

Quality Assurance and Source Inspection

Contract #: 04-0120F4Cty: SF/ALA Rte: 80 PM: 13.2/13.9File #: 69.28**WELDING INSPECTION REPORT****Resident Engineer:**Siegenthaler, Peter**Address:** 333 Burma Road**City:** Oakland, CA 94607**Report No:** WIR-019320**Date Inspected:** 14-Jan-2011**Project Name:** SAS Superstructure**OSM Arrival Time:** 700**Prime Contractor:** American Bridge/Fluor Enterprises, a JV**OSM Departure Time:** 1900**Contractor:** Zhenhua Port Machinery Company, Ltd (ZPMC), Changxing Island **Location:** Shanghai,China**CWI Name:** Xu Le Feng**CWI Present:** Yes No**Inspected CWI report:** Yes No N/A**Rod Oven in Use:** Yes No N/A**Electrode to specification:** Yes No N/A**Weld Procedures Followed:** Yes No N/A**Qualified Welders:** Yes No N/A**Verified Joint Fit-up:** Yes No N/A**Approved Drawings:** Yes No N/A**Approved WPS:** Yes No N/A**Delayed / Cancelled:** Yes No N/A**Bridge No:** 34-0006**Component:** OBG**Summary of Items Observed:**

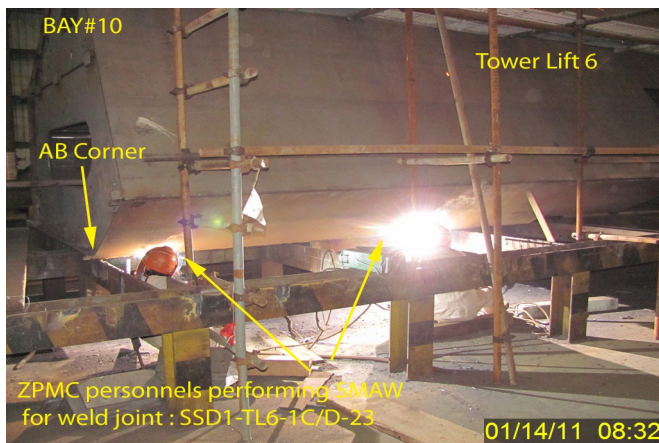
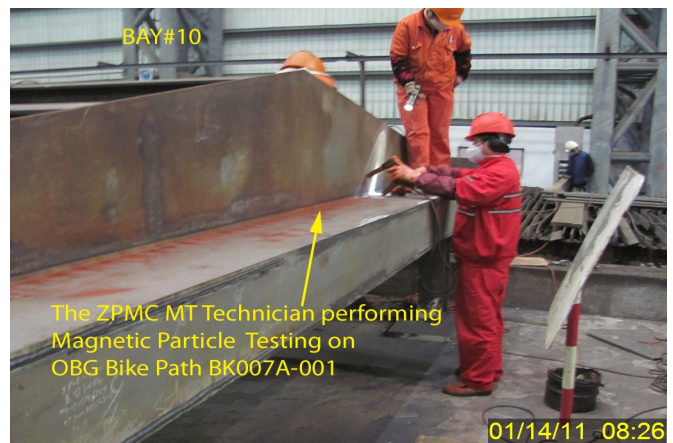
SMAW in the 4G position for the Tower lift 6. The weld joint was designated as: SSD1-TL6-1C/D-23. The welders are identified as #056200 and 500363. ZPMC QC is identified as Mr. Lee peng fei. The welding variables recorded by QC appear to comply with WPS-B-P-2214-TC-U5b. Please see the attached picture.
